November 23, 2011  
File No. 18.0171123.00

Re: Opinion Report  
Little Neck Embankment Stabilization Project  
Cliff and River Roads, Ipswich, MA

**SITE PHOTOGRAPHS**  
**LITTLE NECK, IPSWICH, MA**

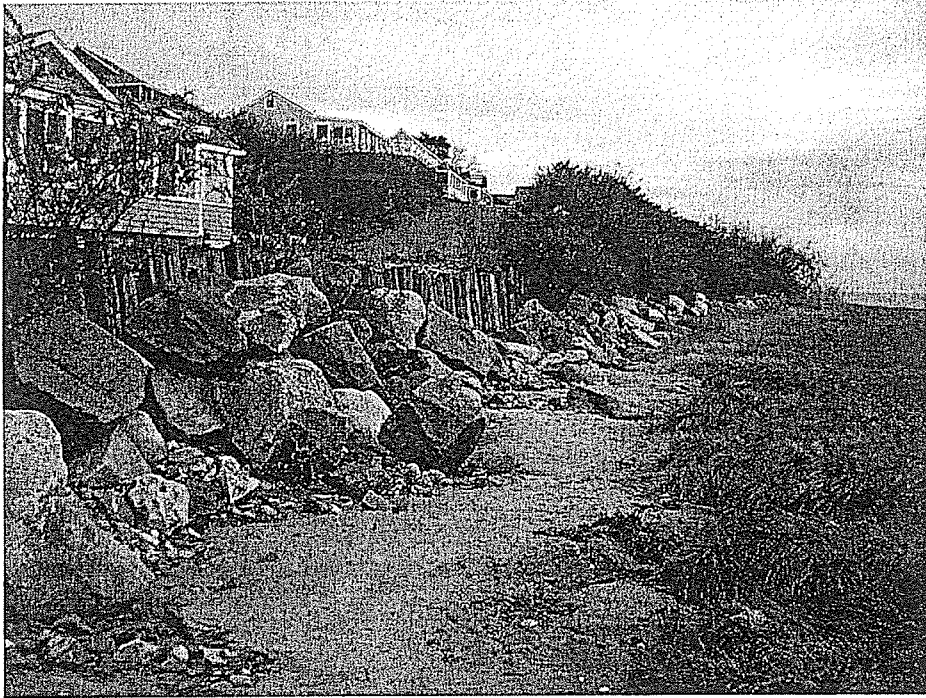
The River Road Area is located on the southern side of Little Neck near the mouth of the Ipswich River and is comprised of a vertical timber wall that extends about 315 linear feet to the east from the entrance to the boat ramp parking area, as illustrated by **Figure 3**. The embankment in this area ranges in height from approximately five to 15 feet. The embankment is protected by a vertical timber retaining wall as illustrated by **Photographs 1 and 2**. The toe of the timber retaining wall is protected by a toe revetment that extends approximately eight feet seaward of the wall. The area directly behind the timber retaining wall consists of a deteriorated concrete cap, gravel shoulder or steep vegetated slope. A public water main and a sanitary sewer line are located within the roadway. For over half the length of the River Road site the paved roadway surface is less than ten feet from the deteriorated timber retaining wall.

Within the River Road Area the observed storm damage consisted of sinkholes behind the timber bulkhead and erosion of River Road. The damage was likely the result of the high water conditions which washed out the backfill along the timber bulkhead during receding tides. At the time of the inspection the erosion and sinkholes had been partially and temporarily stabilized by the placement of stone material to fill in the voids.

**Photograph #1:** View of River Road embankment looking east.

The proposed project at the River Road site consists of the removal of approximately 315 linear feet of the existing vertical timber wall and stone toe protection and the installation of a new stone revetment and cap stone. The existing wall and toe stones will be removed and replaced with the new revetment. The proposed stone revetment will be constructed of two foot thick armor stone layer with bedding stone placed on 1 vertical to 1.5 horizontal and 1 vertical to 1 horizontal slopes. A two foot thick capstone will be placed at the top of the slope to provide further wave protection and curbing. The existing stones will utilized within the new revetment. The new stone revetment will be located within the footprint of the existing toe stones, timber wall and concrete cap.

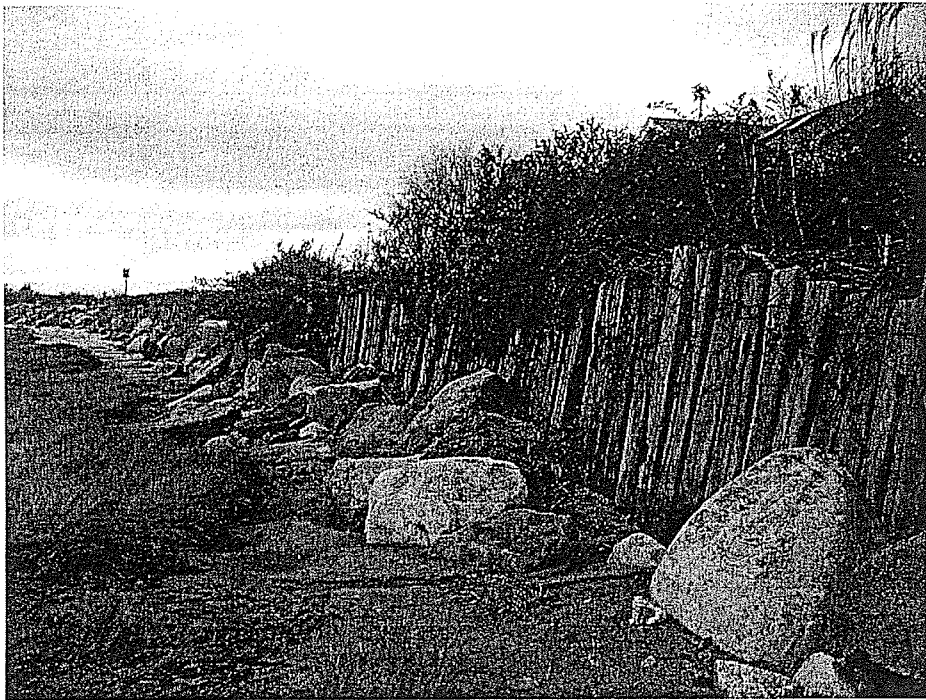
**Photograph #2:** View of River Road embankment looking west.

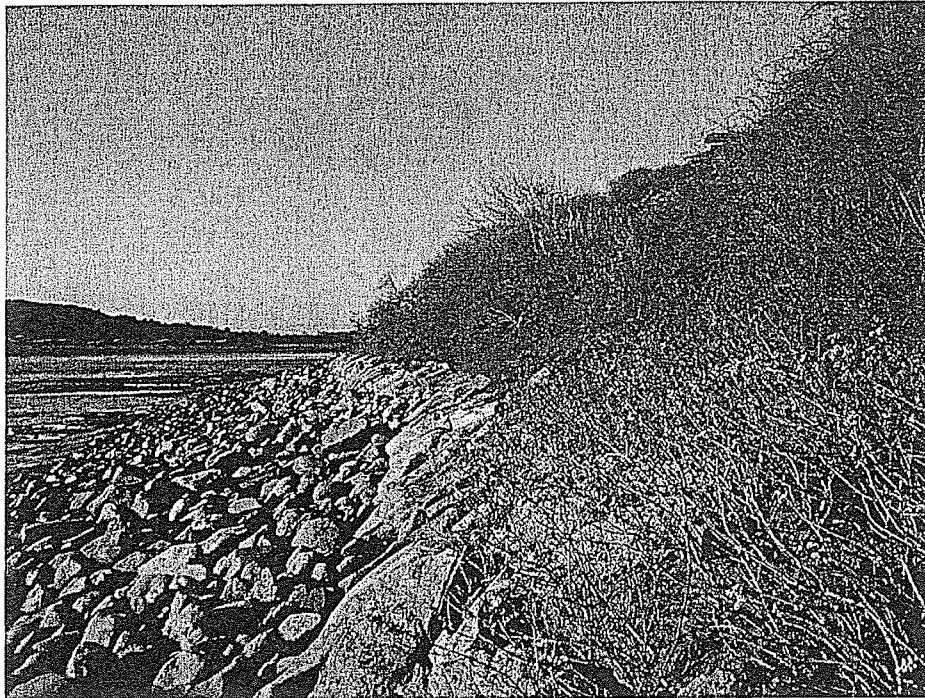
The River Road and Cliff Road Areas are separated by approximately 900 feet of embankment. The embankment in this area consists of a stone revetment which in the upper sections is overgrown with vegetation, as illustrated by **Photograph 3**. The embankment in this area ranges in height from approximately 20 to 55 feet.

The stone revetment within the embankment between the two project areas appeared to have weathered the storm conditions well and no apparent areas of damage due to the storm waves were observed.

**Photograph #3:** View of existing revetment looking south.

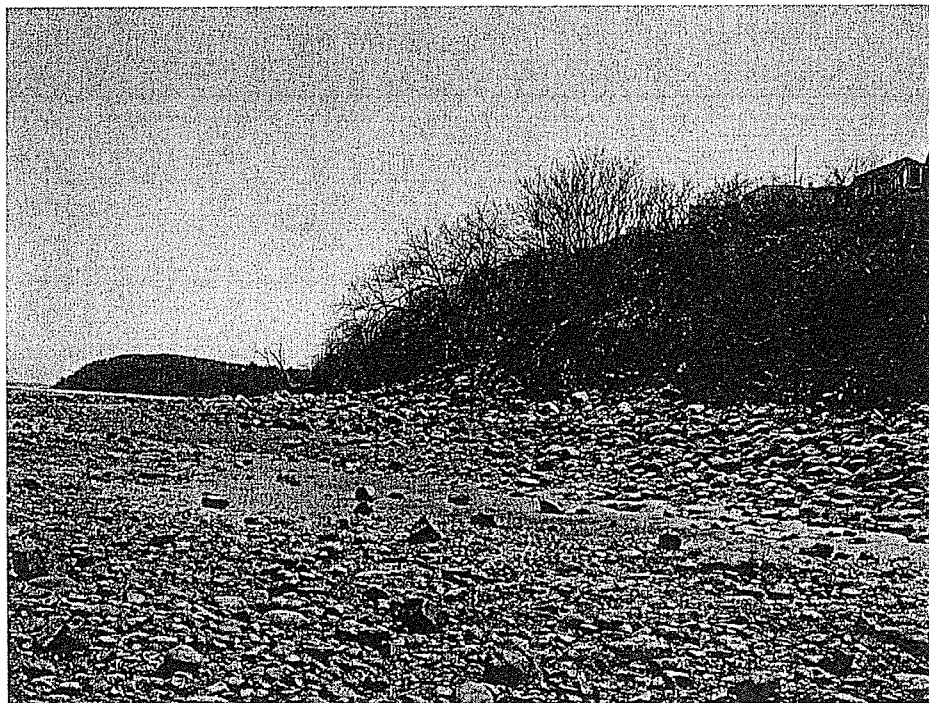
The Cliff Road Area is located on the east side of Little Neck adjacent to Plum Island Sound. The Cliff Road embankment extends from the terminus of the Revetment Area approximately 600 linear feet to the northwest to Pavilion Beach. The embankment is comprised of a steep naturally vegetated slope and is backed by lawn areas, Cliff Road and several houses, as illustrated by **Photographs 4 and 5**. Both a public water main and sanitary sewer are located within the paved roadway. A single catch basin is located at the north end of Cliff Road. The catch basin drains onto the adjacent embankment.

**Photograph #4:** View of Cliff Road embankment in winter looking south.

The proposed project at Cliff Road site involves an approximately 600 foot extension of the adjacent stone revetment to the north. The upper eroded areas of the slope will be loamed and vegetated. The proposed stone revetment will extend from the toe of the existing bank to elevation 25 NAVD. In areas where the top of the bank is below elevation 25, the revetment will only extend to the existing top of slope. The eroded portions of the bank above elevation 25 NAVD will be re-graded to match the grade of the new revetment, and then planted with erosion control/salt tolerant grass.

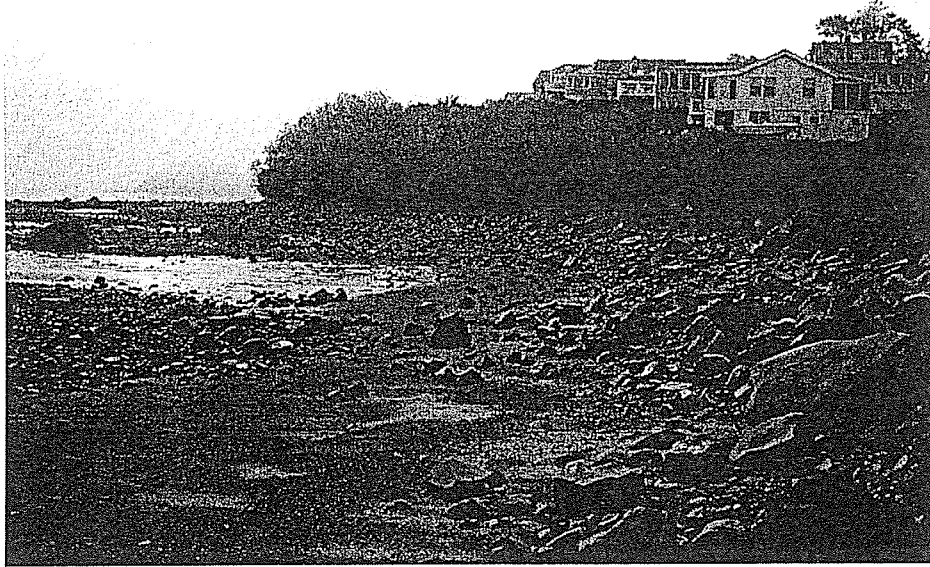
**Photograph #5:** View of Cliff Road embankment from Pavilion Beach.

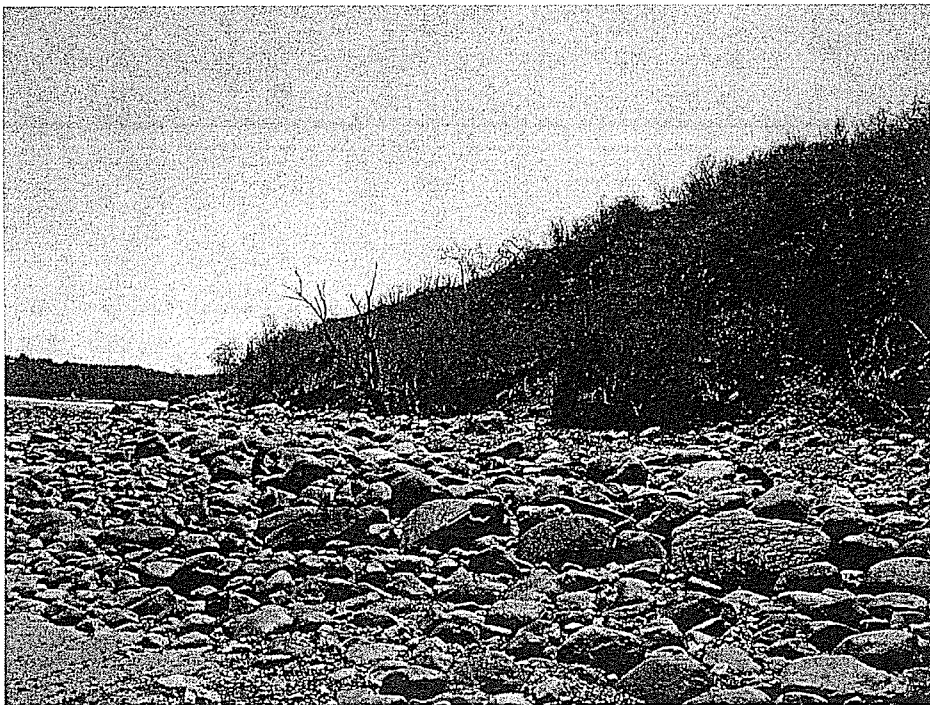
The Cliff Road Area embankment was observed to have general sloughing of the embankment slope. This condition appears to be due to the high tide and wave action saturating and eroding the toe area, which caused subsequent instability and sloughing of the slope. This type of condition appeared in four locations extending for a total length of approximately 400 to 500 feet. The sloughing extending up about 2/3 of the approximate 30 foot height of the embankment. **Photographs 6, 7, 8 and 9** illustrate the general conditions observed after the 2007 Northeaster.

**Photograph #6:** View of storm damage along Cliff Road embankment.

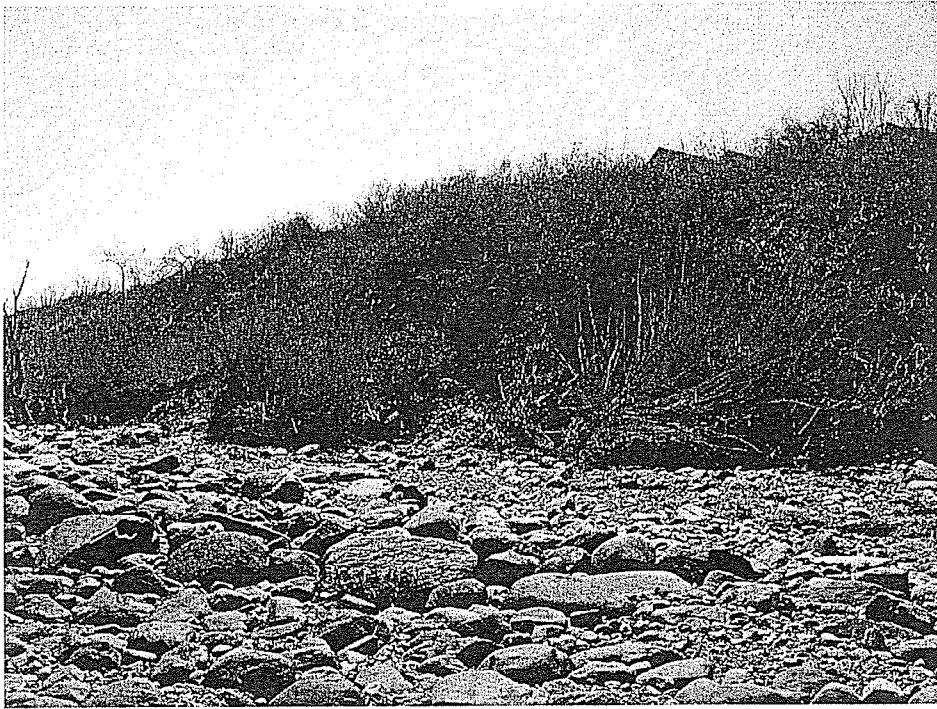
**Photograph #7:** View of storm damage at toe of Cliff Road embankment.

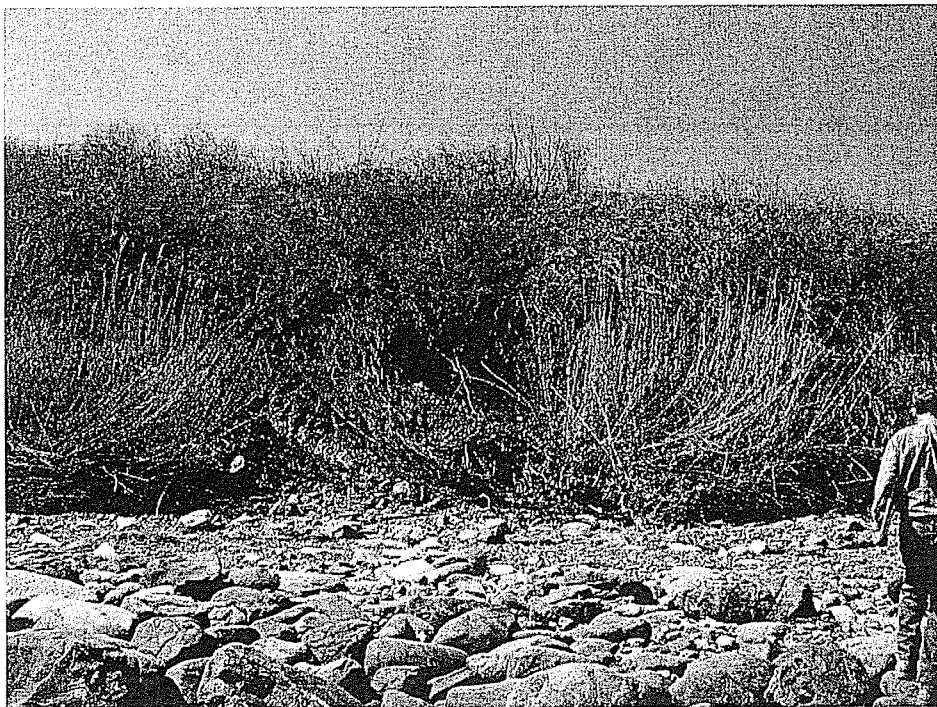
**Photograph #8:** Close up view of storm damage along Cliff Road embankment.

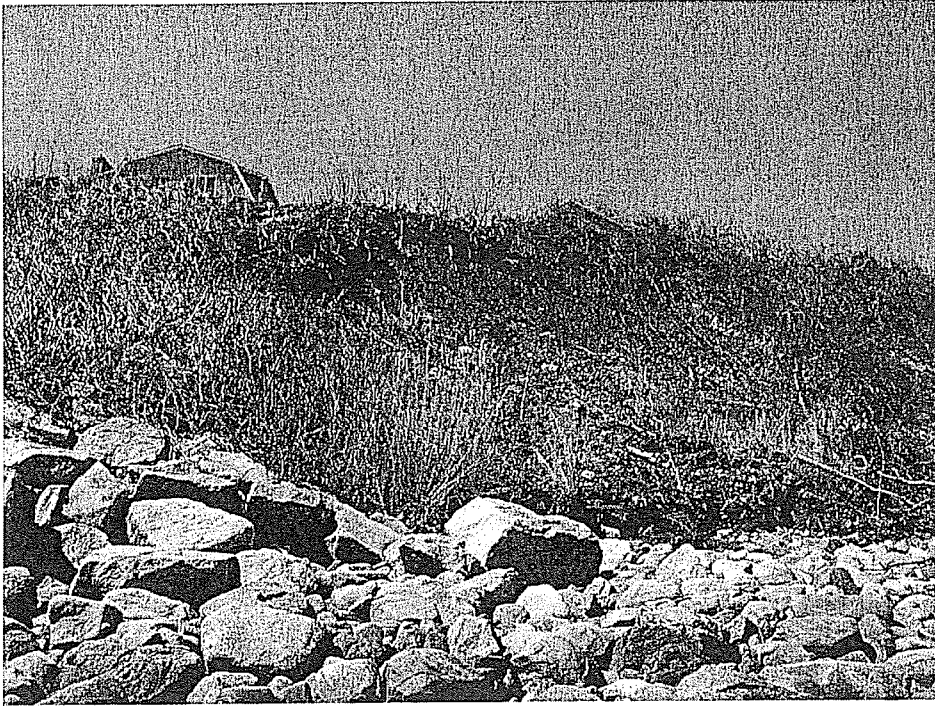
Without the proposed Project, the sloughing and erosion of the Cliff Road embankment will continue to occur and may occur more frequently. Predicting long term erosion rates for these types of shorelines is difficult since erosion of the embankment is highly dependent upon the frequency of severe storm events. Over the long term the continued erosion of the Cliff Road embankment will eventually impact Cliff Road and the utilities located within the Road. In addition, the continued erosion will soon start to impact the stability of the adjacent existing stone revetment to the south.

**Photograph #9:** View of Cliff Road embankment storm damage adjacent to the existing revetment.
